**Kermit Creek: Restoring  
salmonid habitat on  
“working lands” on the  
Southern Oregon Coast**

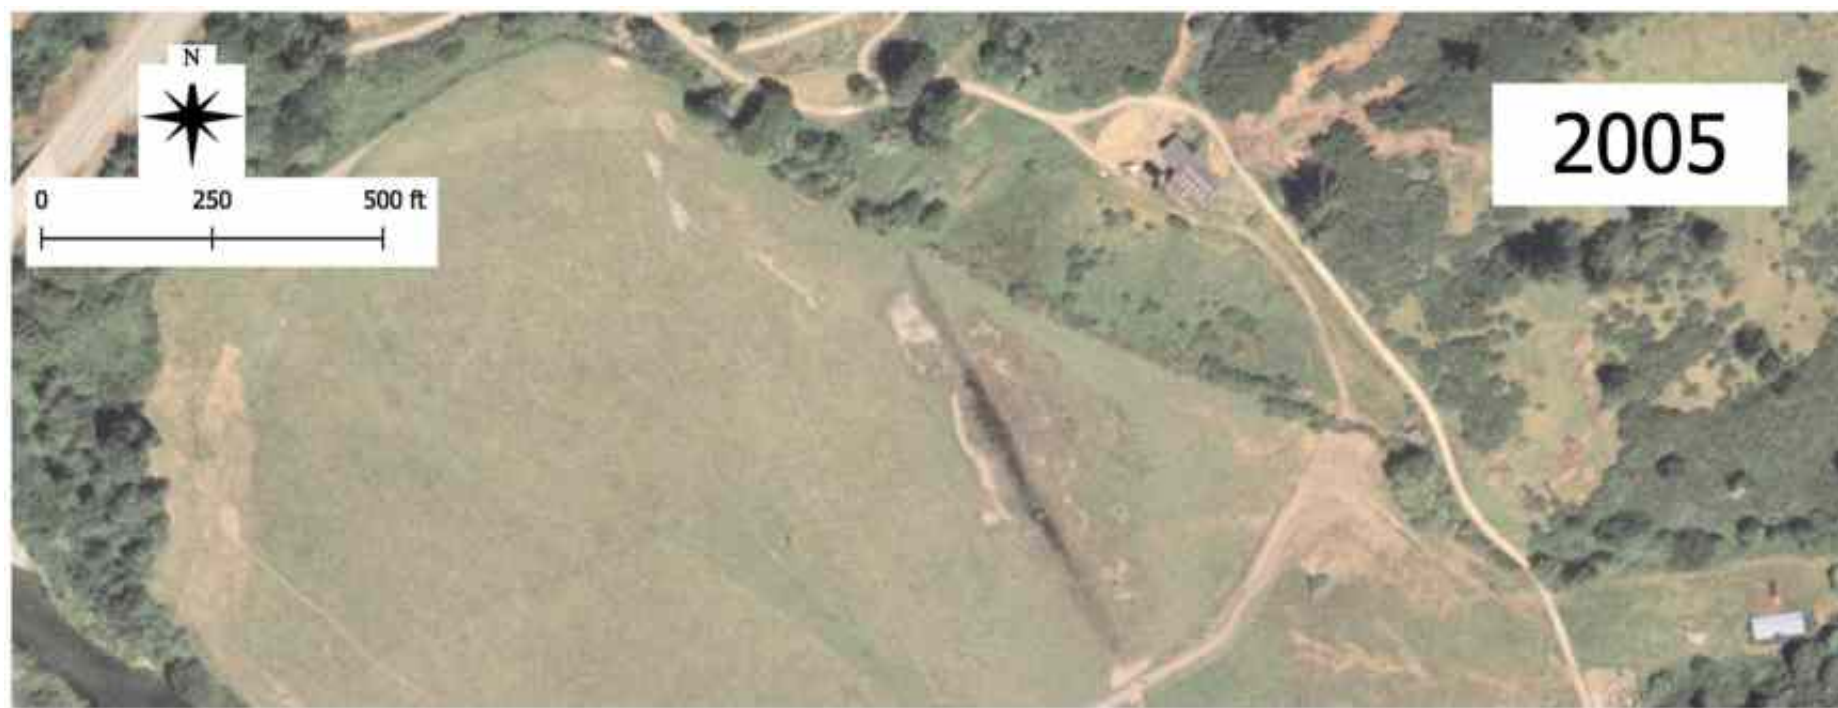
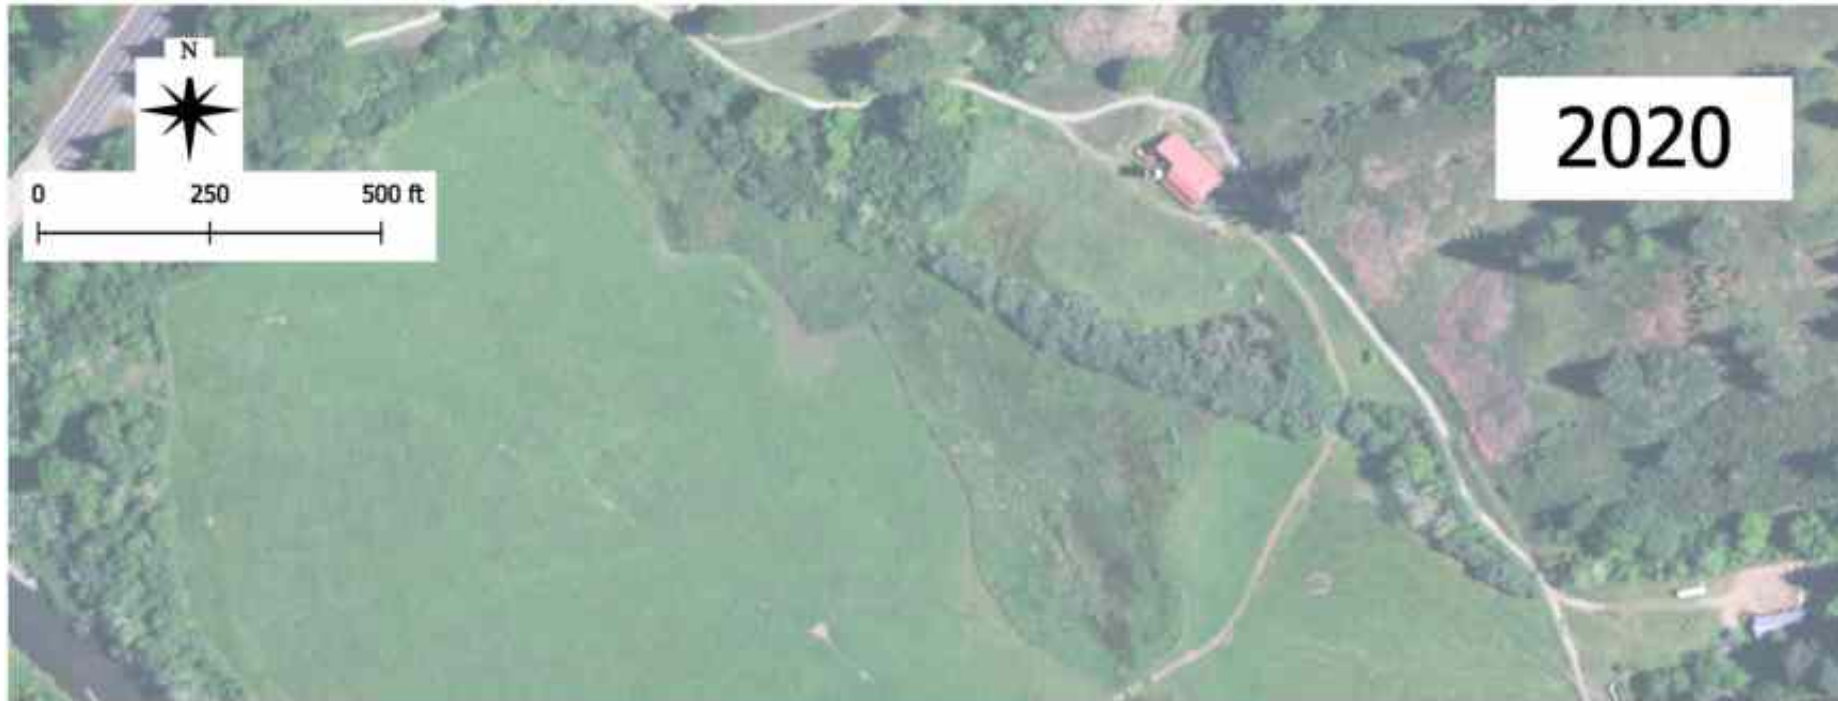
## Kermit Creek in 2020

- Riparian revegetation trending upward
- Depositional area developing at base of alluvial fan
- Stream channel simplified US of wetland
- Wetland dominated by reed canary grass
- Stream diverting through pasture
- BPA road impeding fish passage & bedload

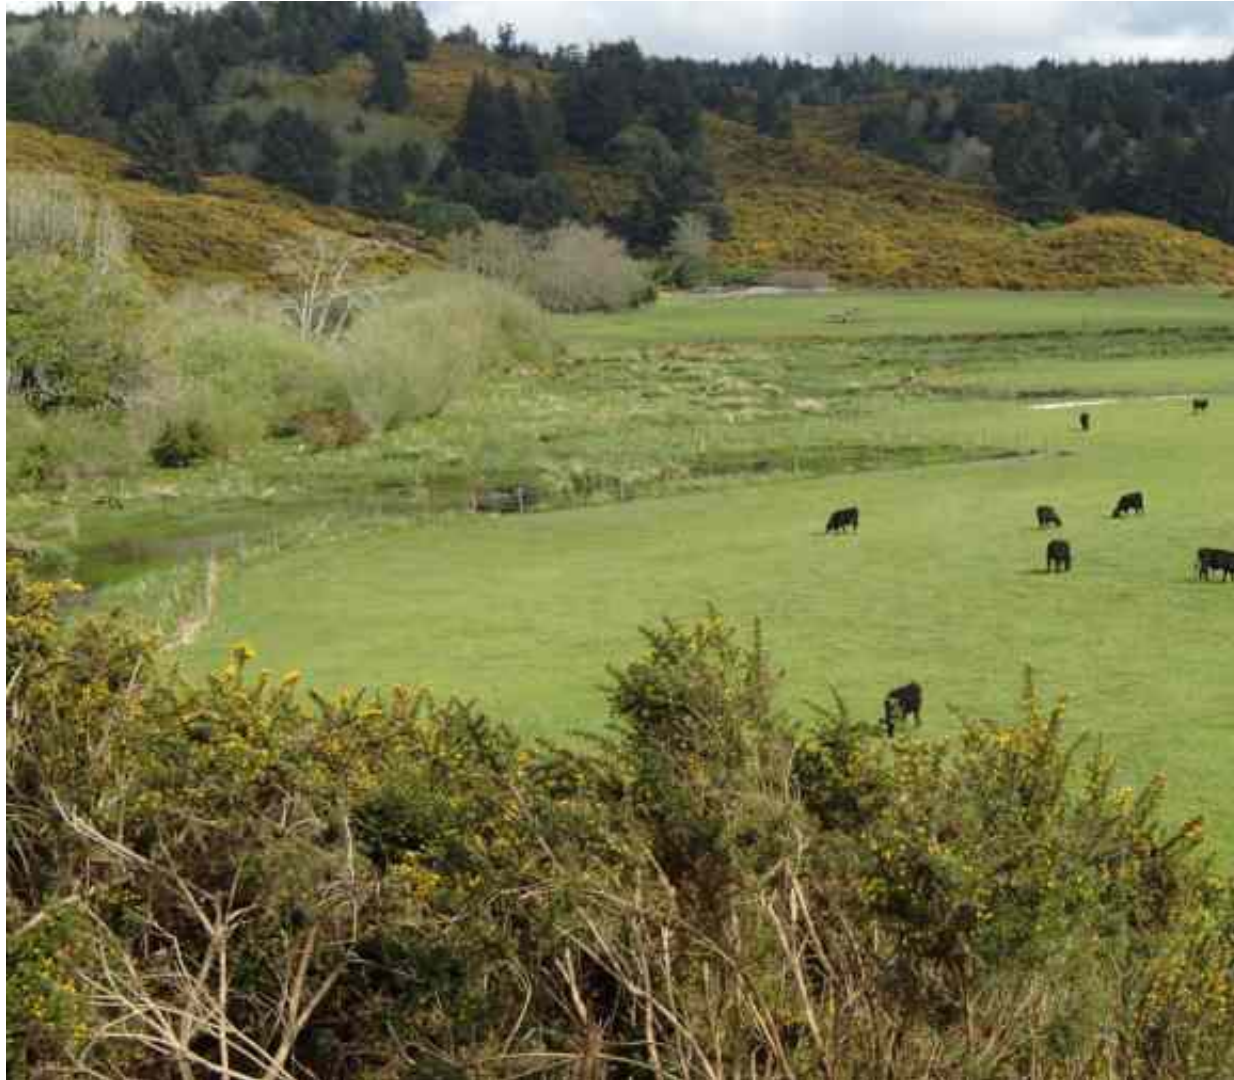
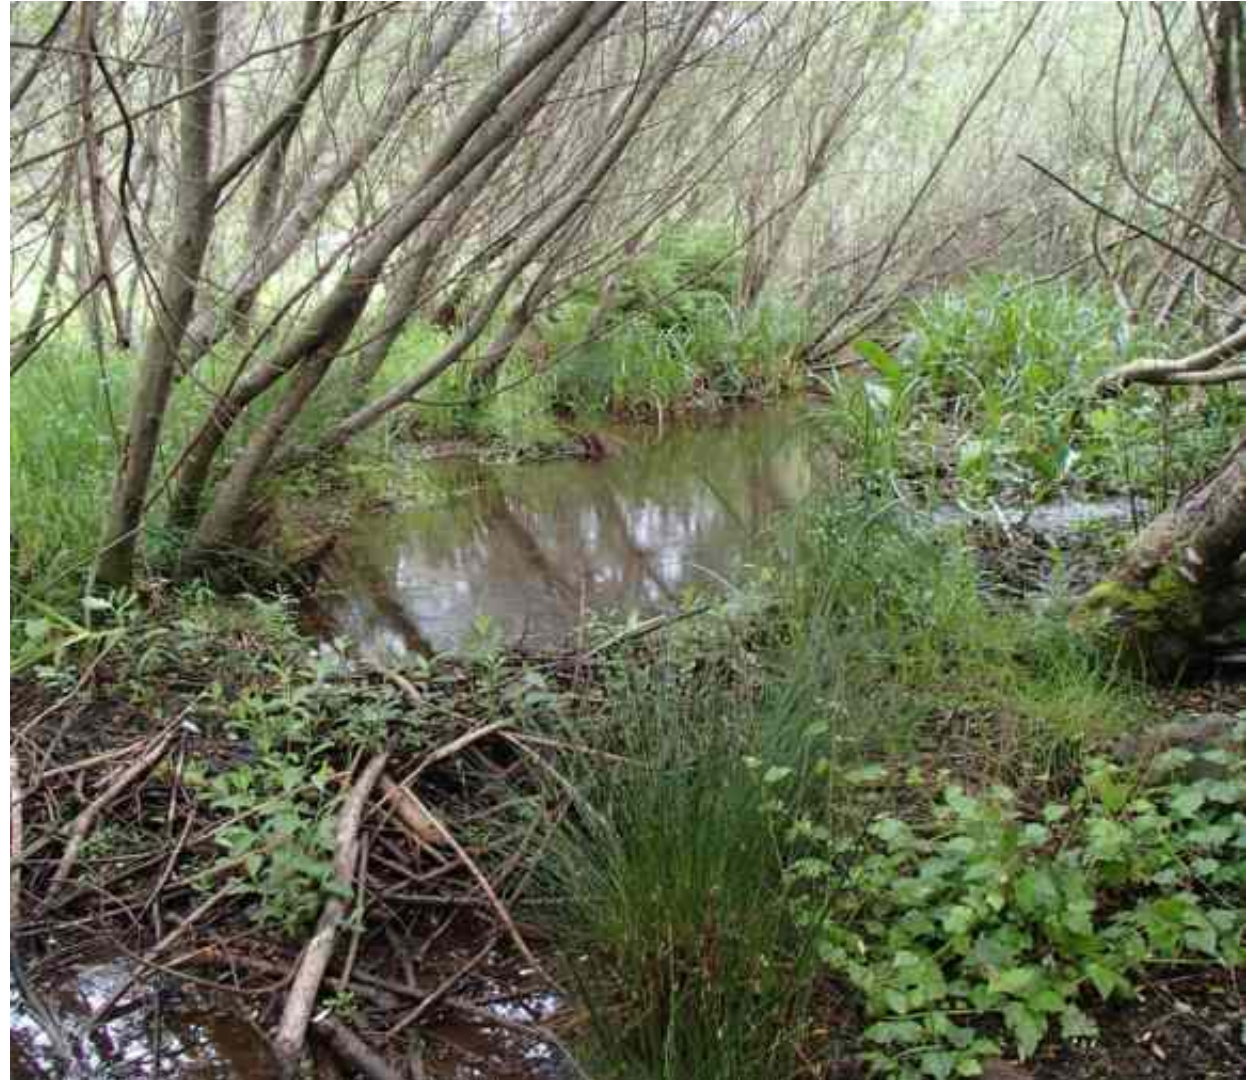
## Kermit Wetland

- Broad and shallow; become isolated ponds in spring
- Dominated by reed canary grass; minimal CREP seedling survival
- Ditched Kermit Creek channel dammed by beaver; braiding into wetland and north into floodplain

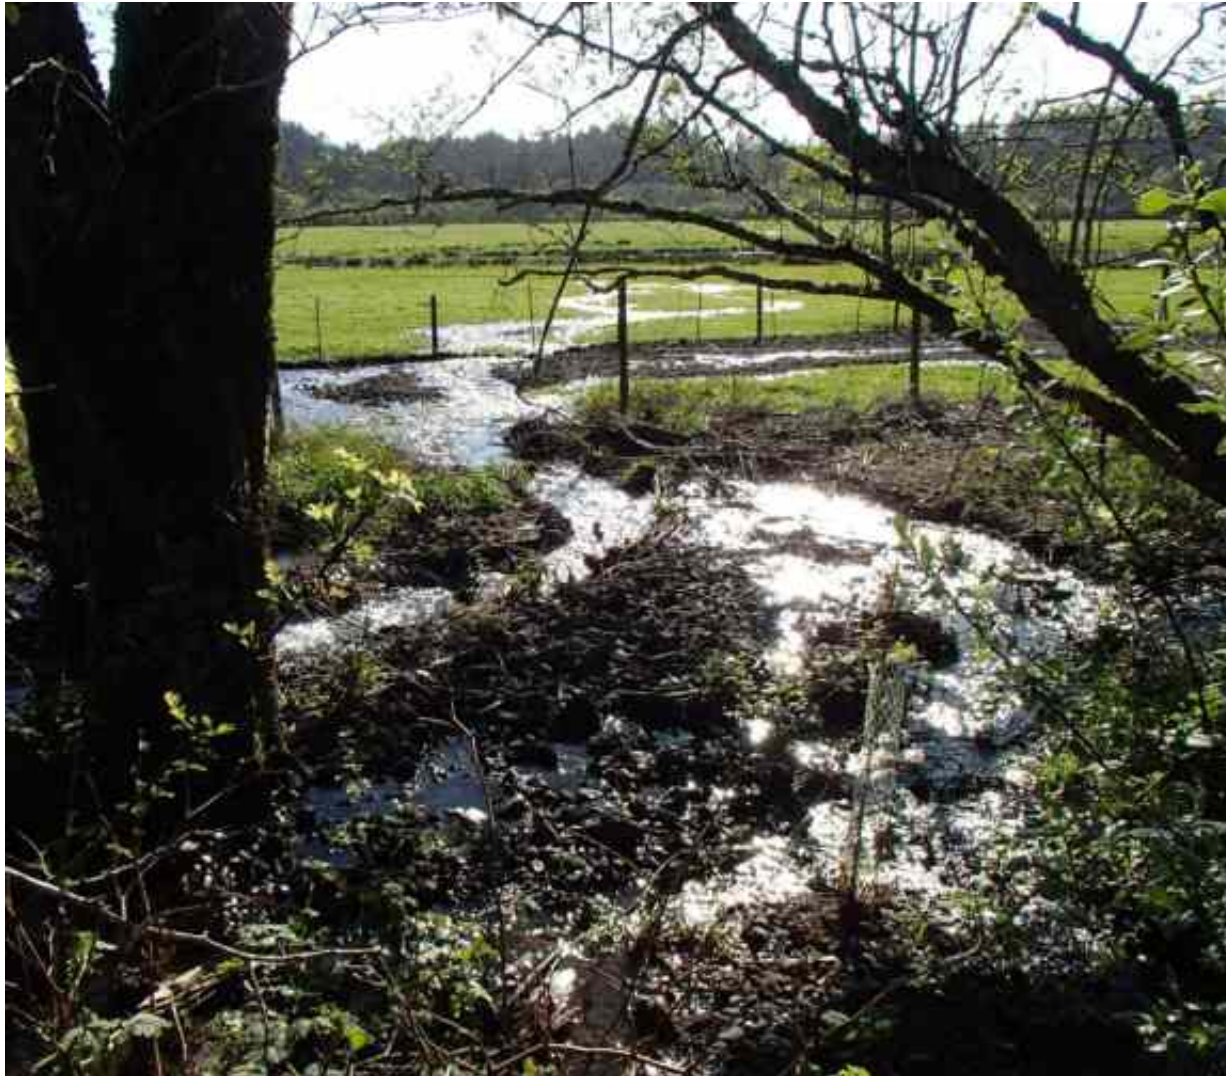
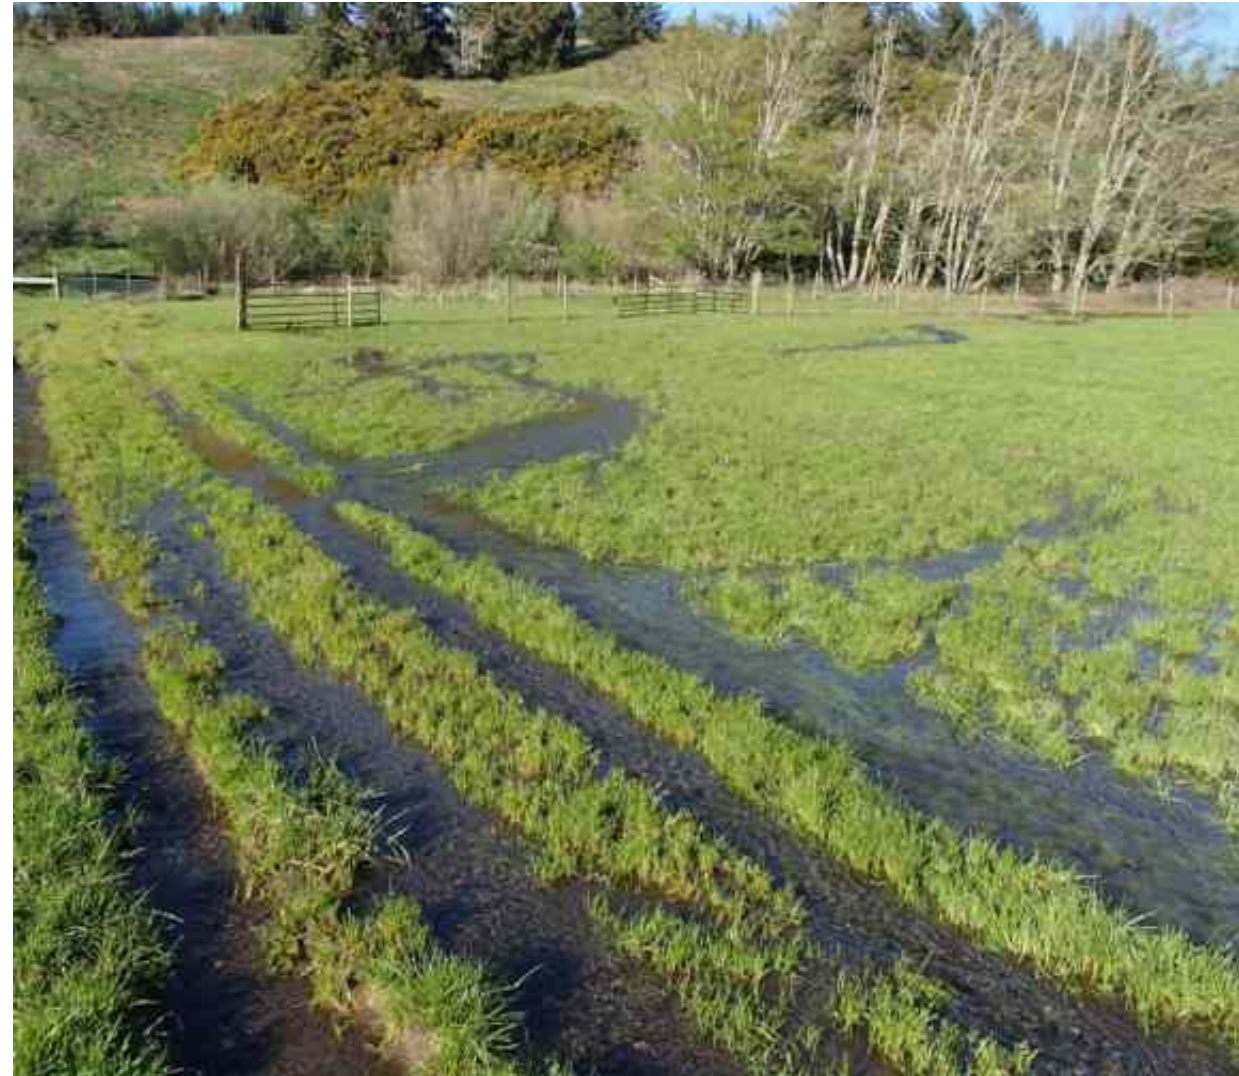
## Kermit Creek Diversion

- Ditched stream channel no longer “maintained” and colonized by willow
- Channel filled with bedload, diverted from stream corridor because it was “perched”
- Potentially strand fish; entrain sediment and nutrients; dewater downstream channel; ruin livestock pasture

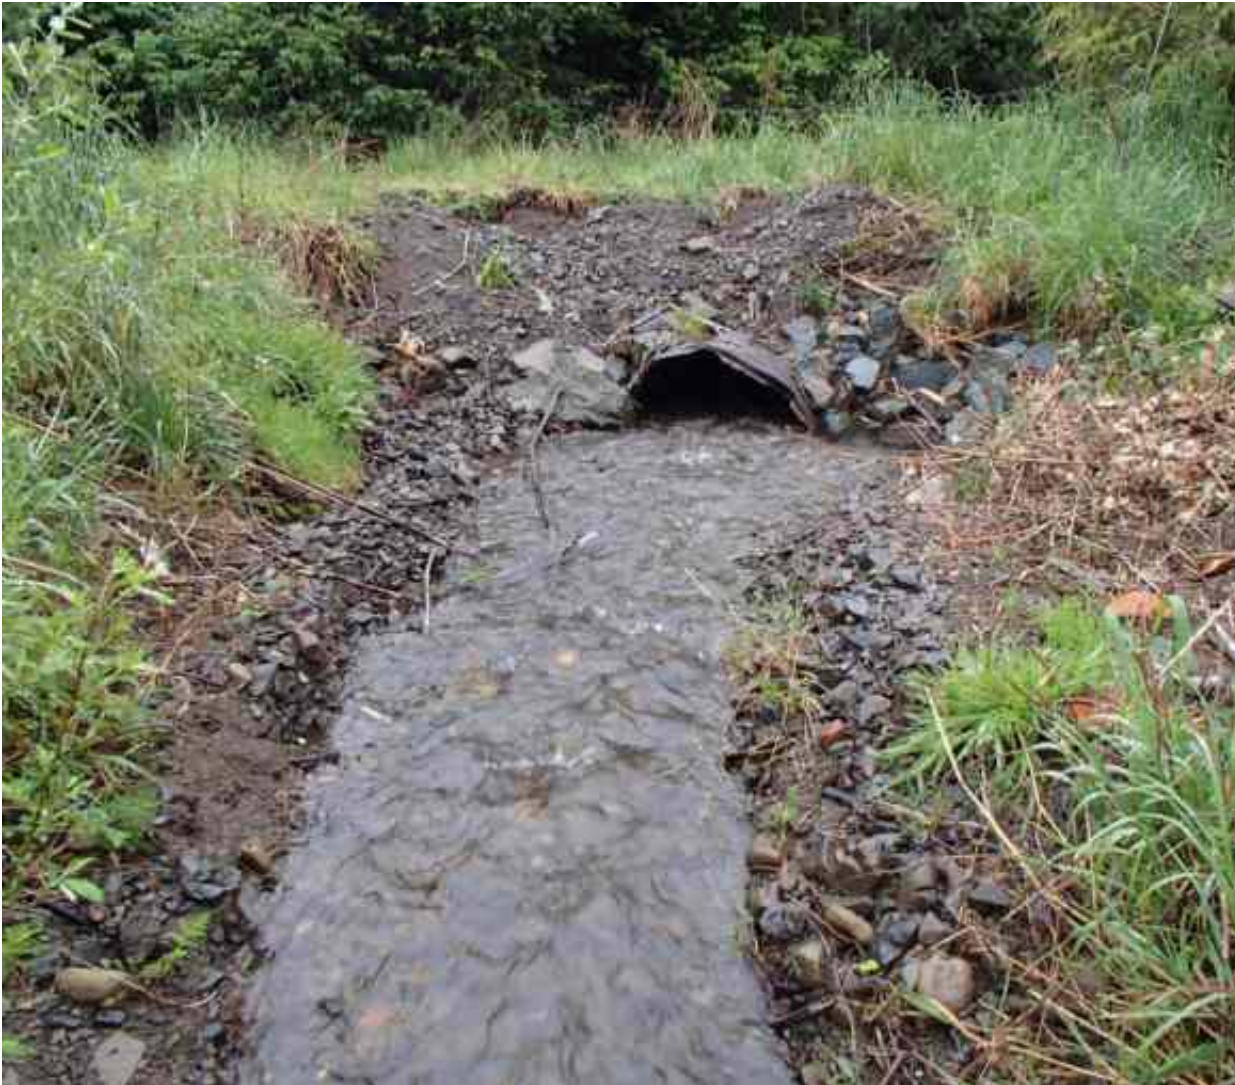
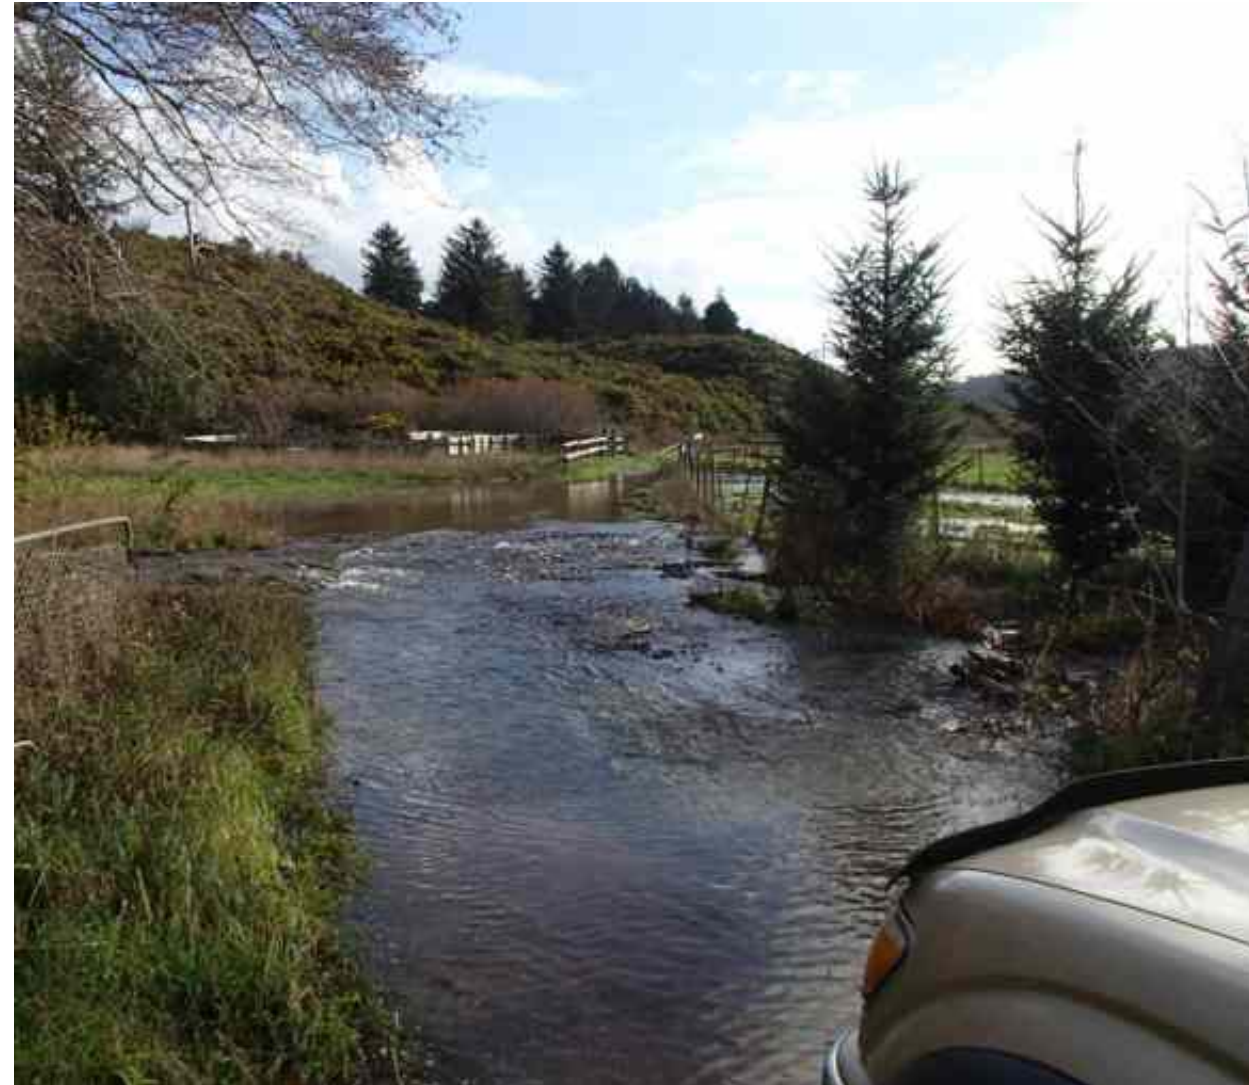
## Bonneville Power Administration (BPA) Road Crossing

- Impeded fish passage and bedload movement
- Culvert frequently plugged, causing Kermit Creek to divert through pasture

- Bridge installation on BPA road restored fish passage to 0.8 miles of habitat and bedload movement
- Project site experienced an ~25-year flood event in March 2025 without failure – sustained overland river flow
