# **Living Shorelines for Coastal Resilience: A Combined Oyster – Eelgrass Restoration Approach**

# Newport Bay Living Shorelines

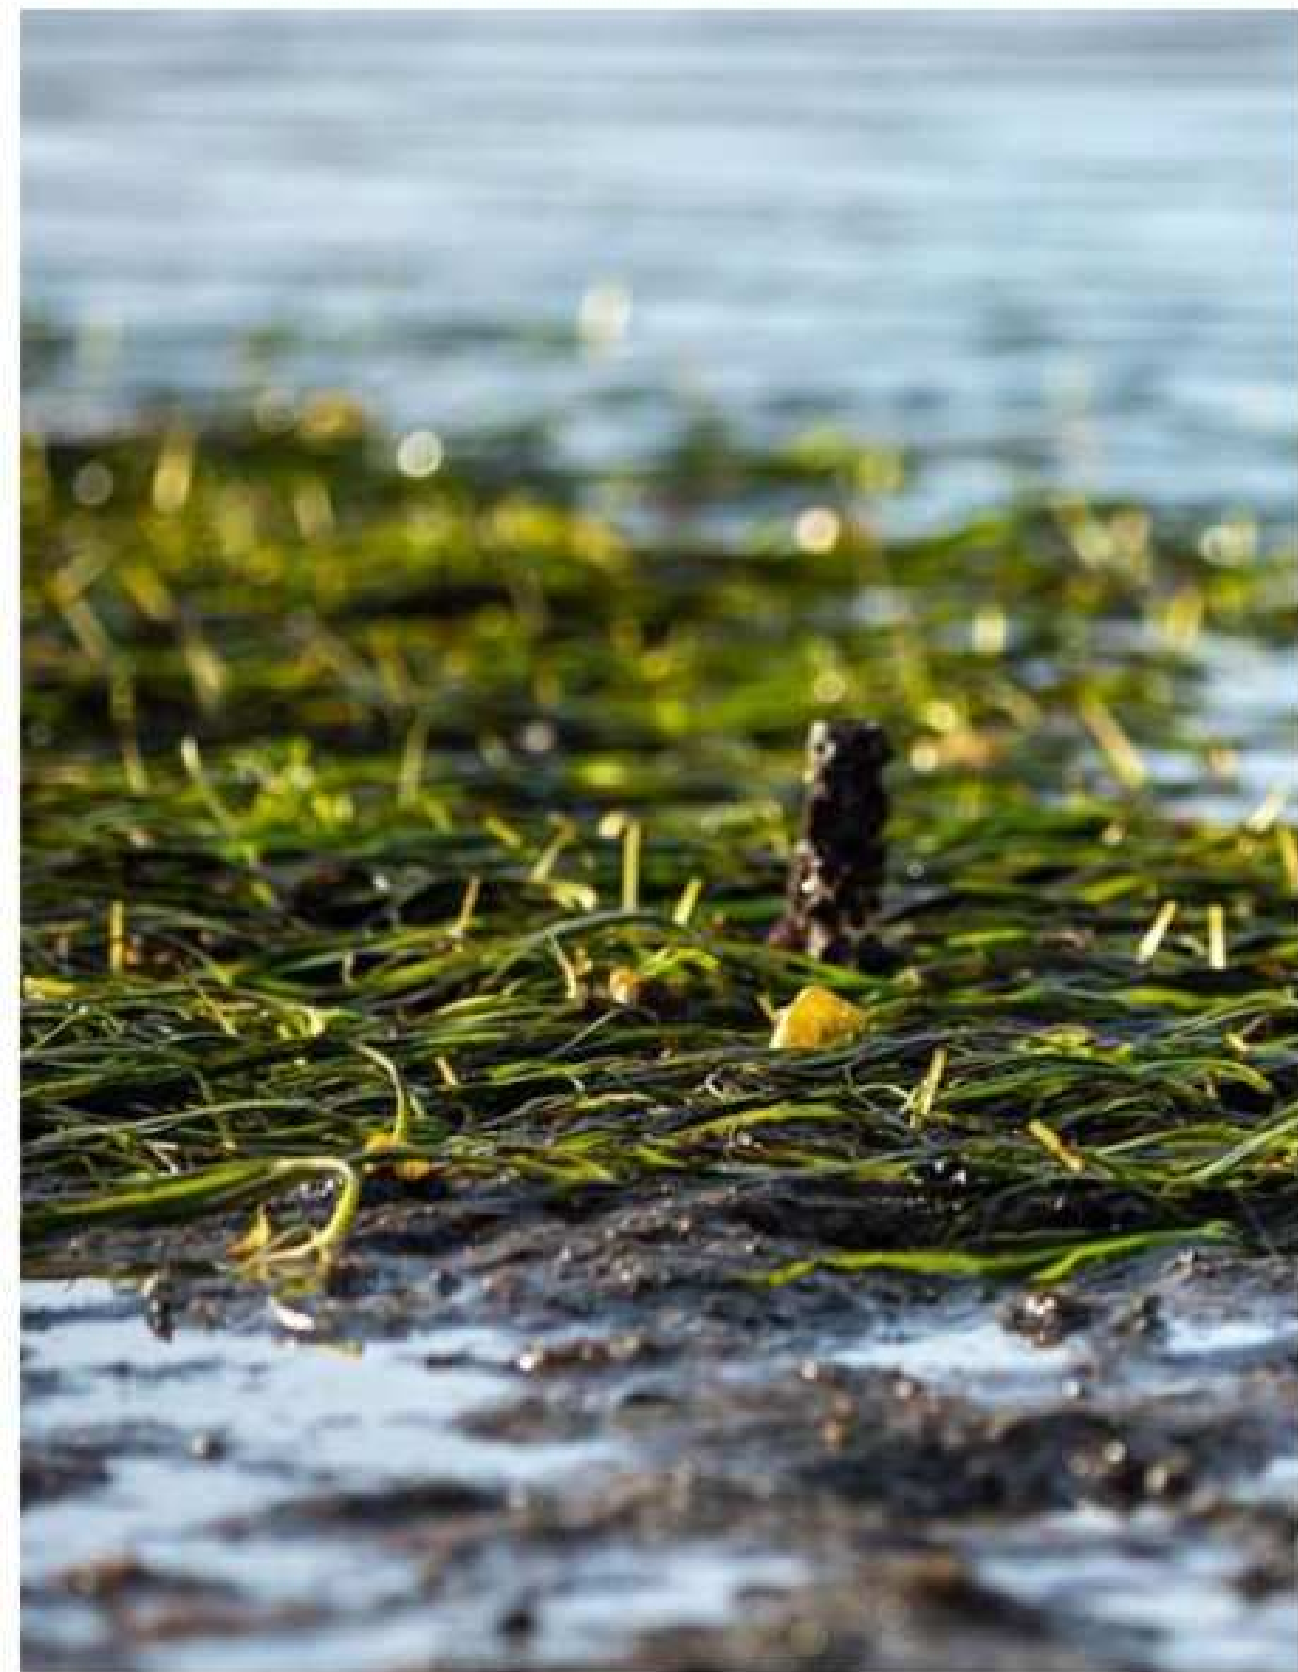
Post-restoration: eelgrass density has ranged from 3 to 8 X greater than pre-restoration densities

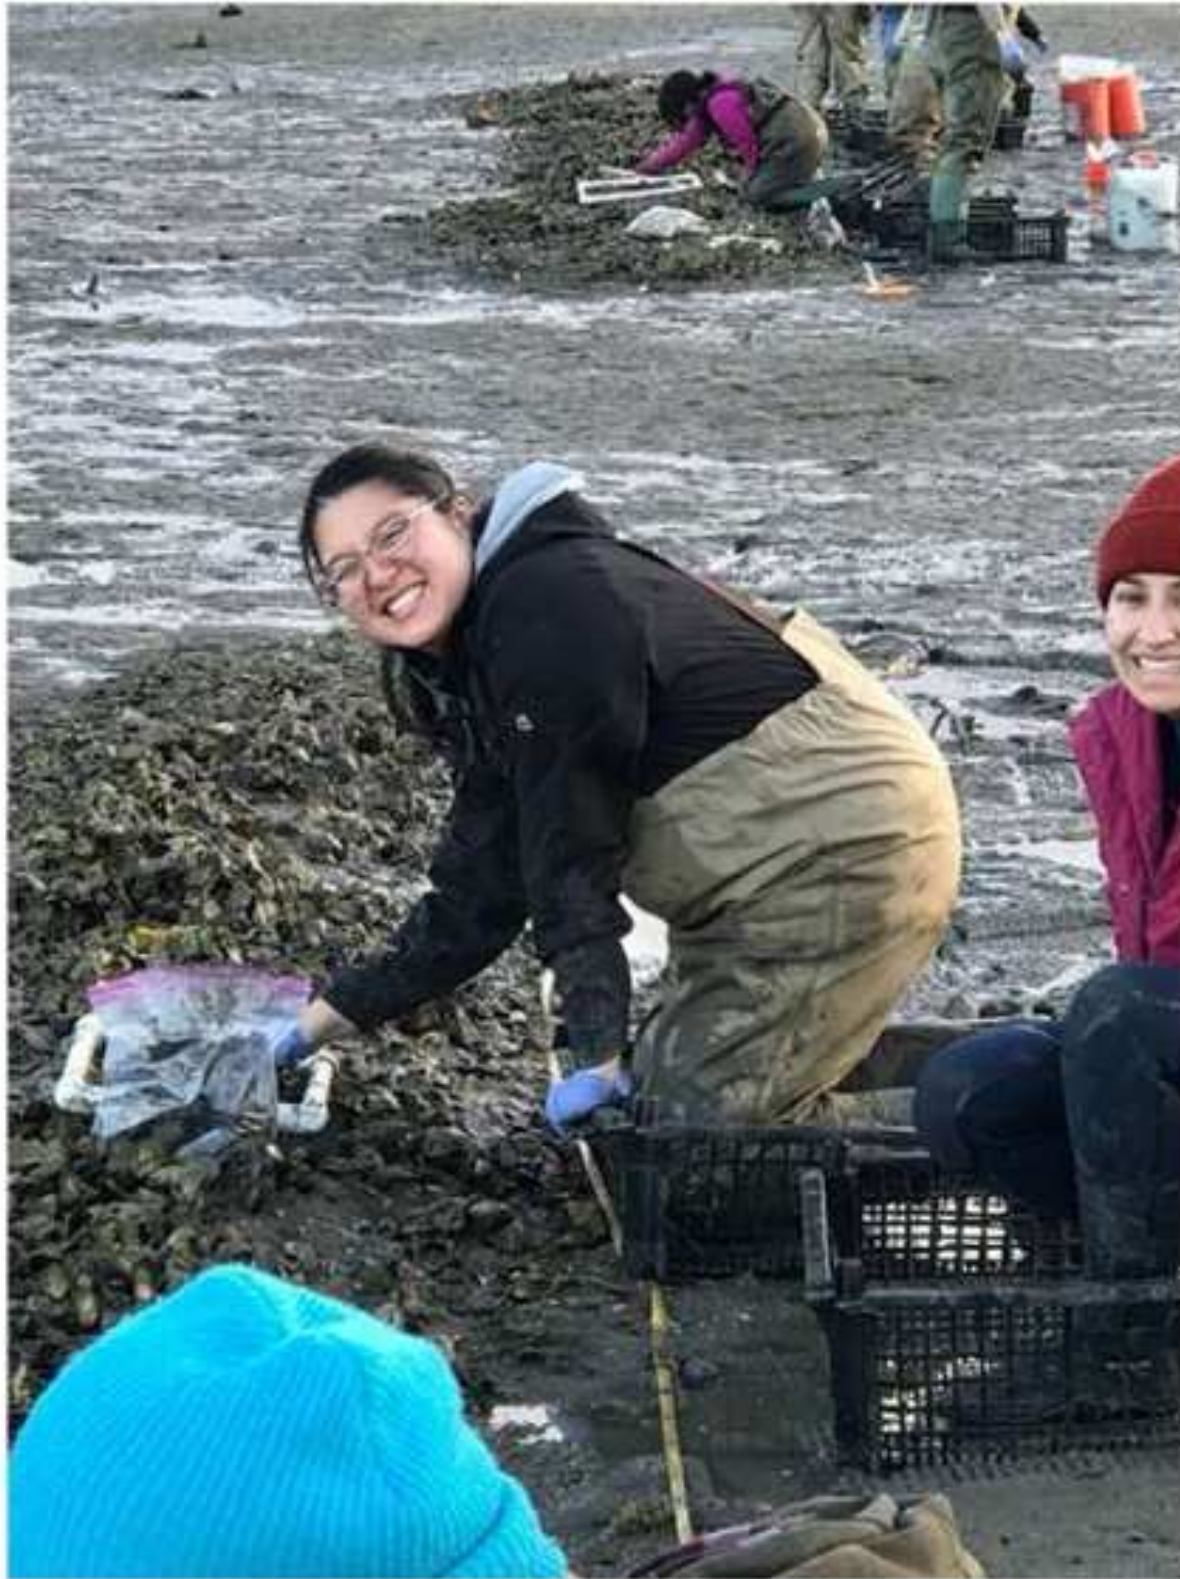
# Post-restoration oyster density up to 25 X greater than pre-restoration; declined substantially in 2020 – 2 X greater in 2023

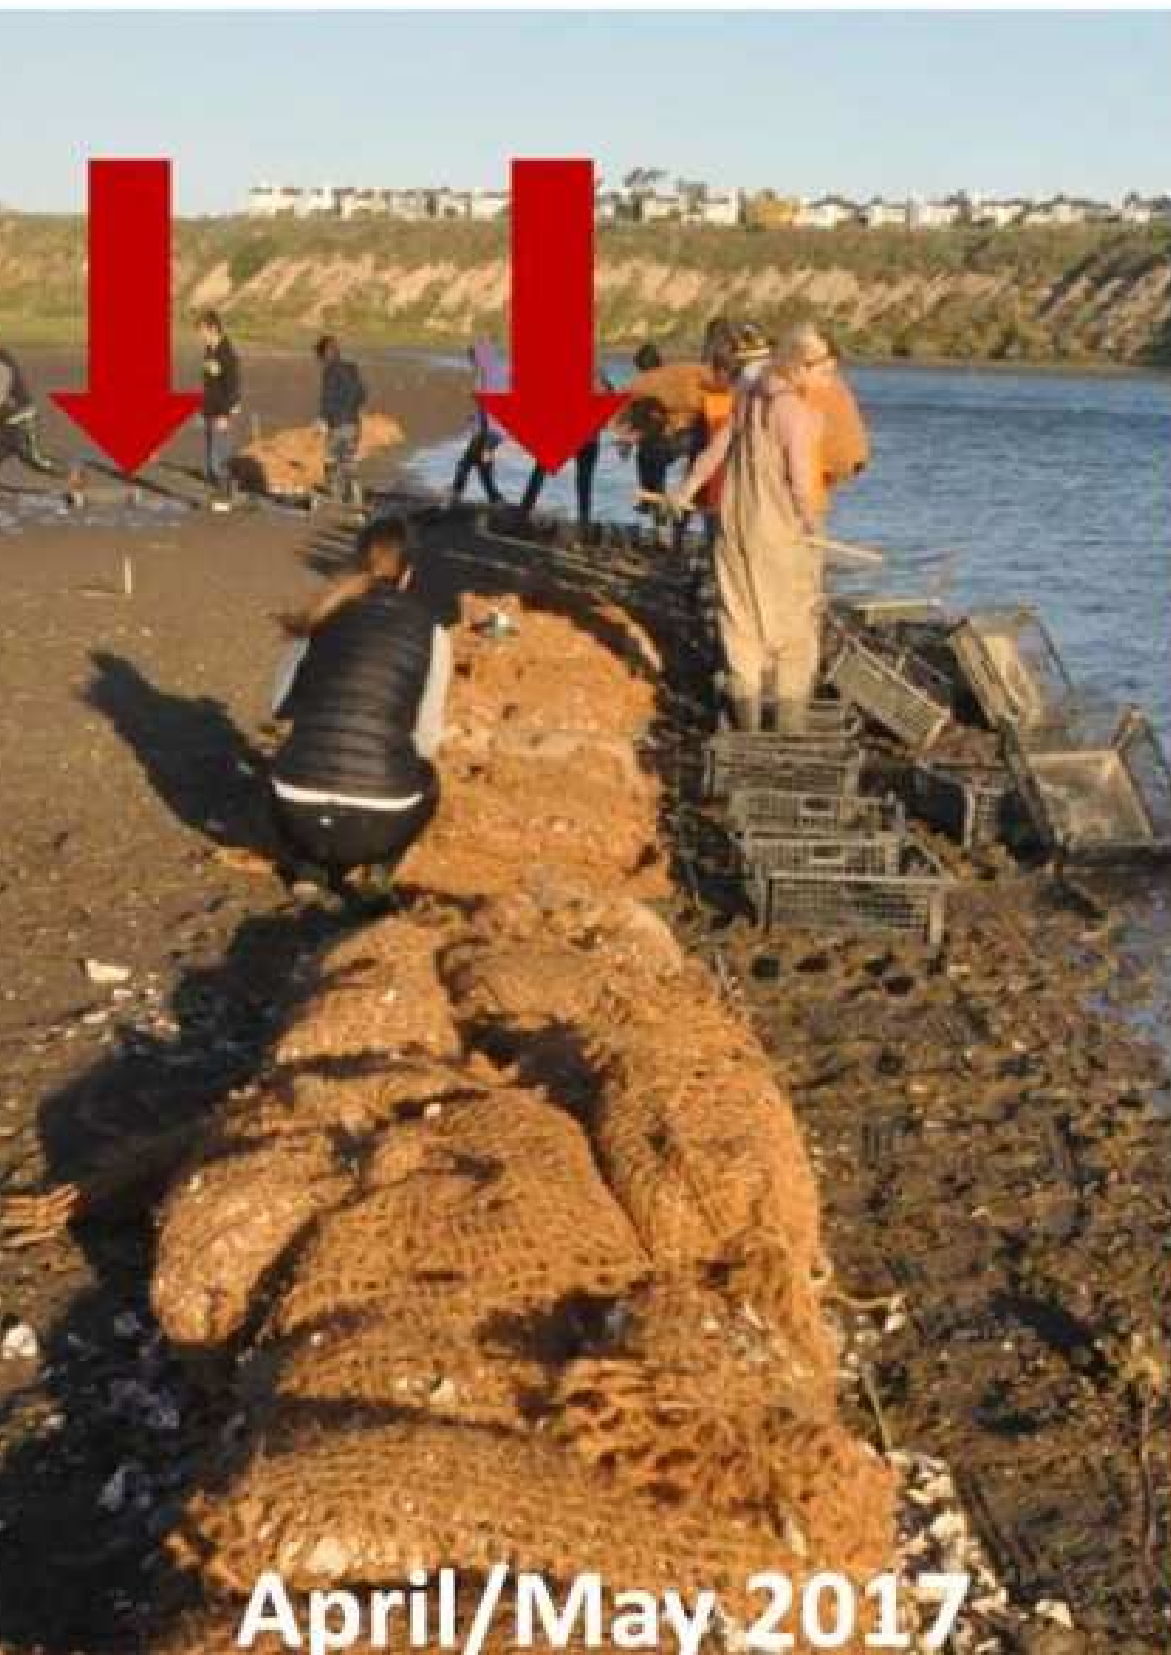
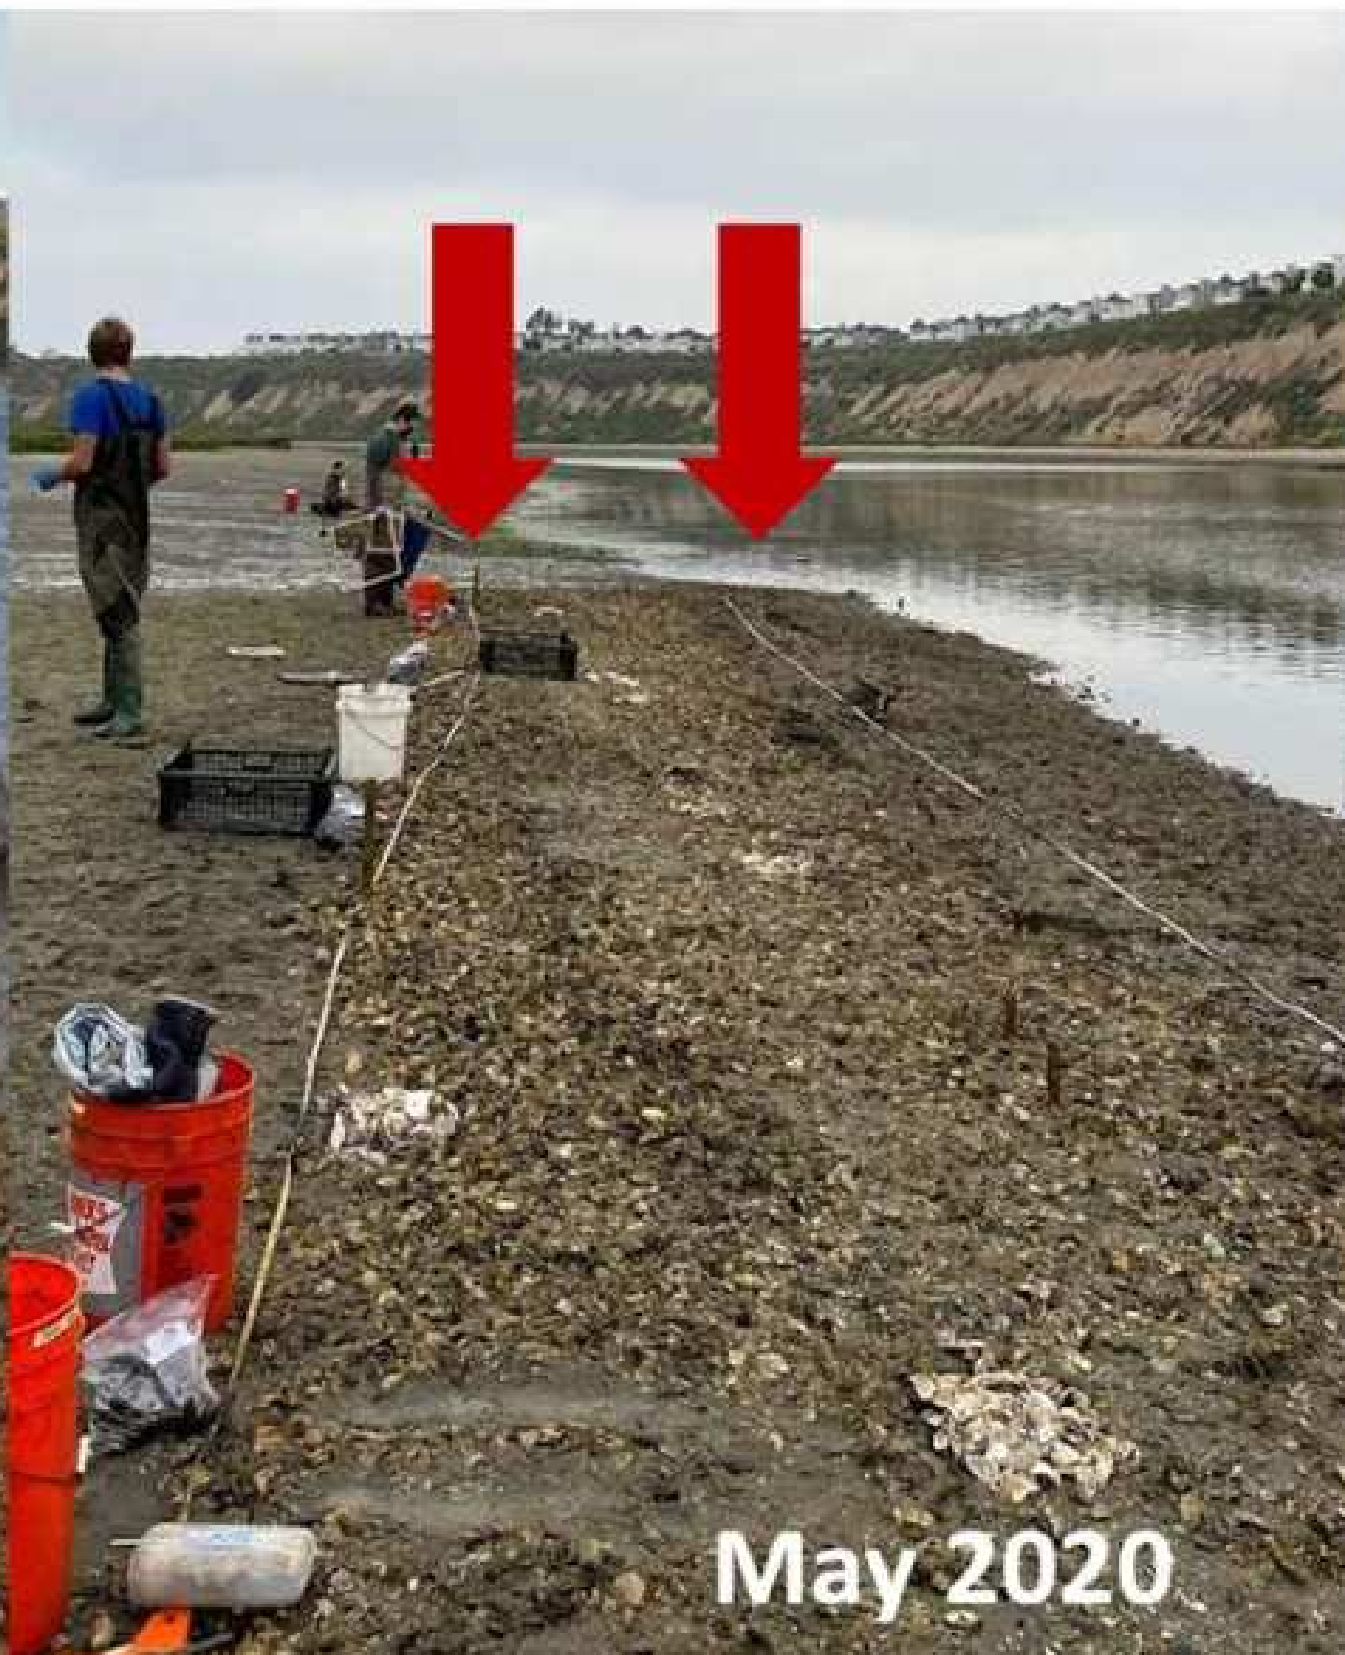
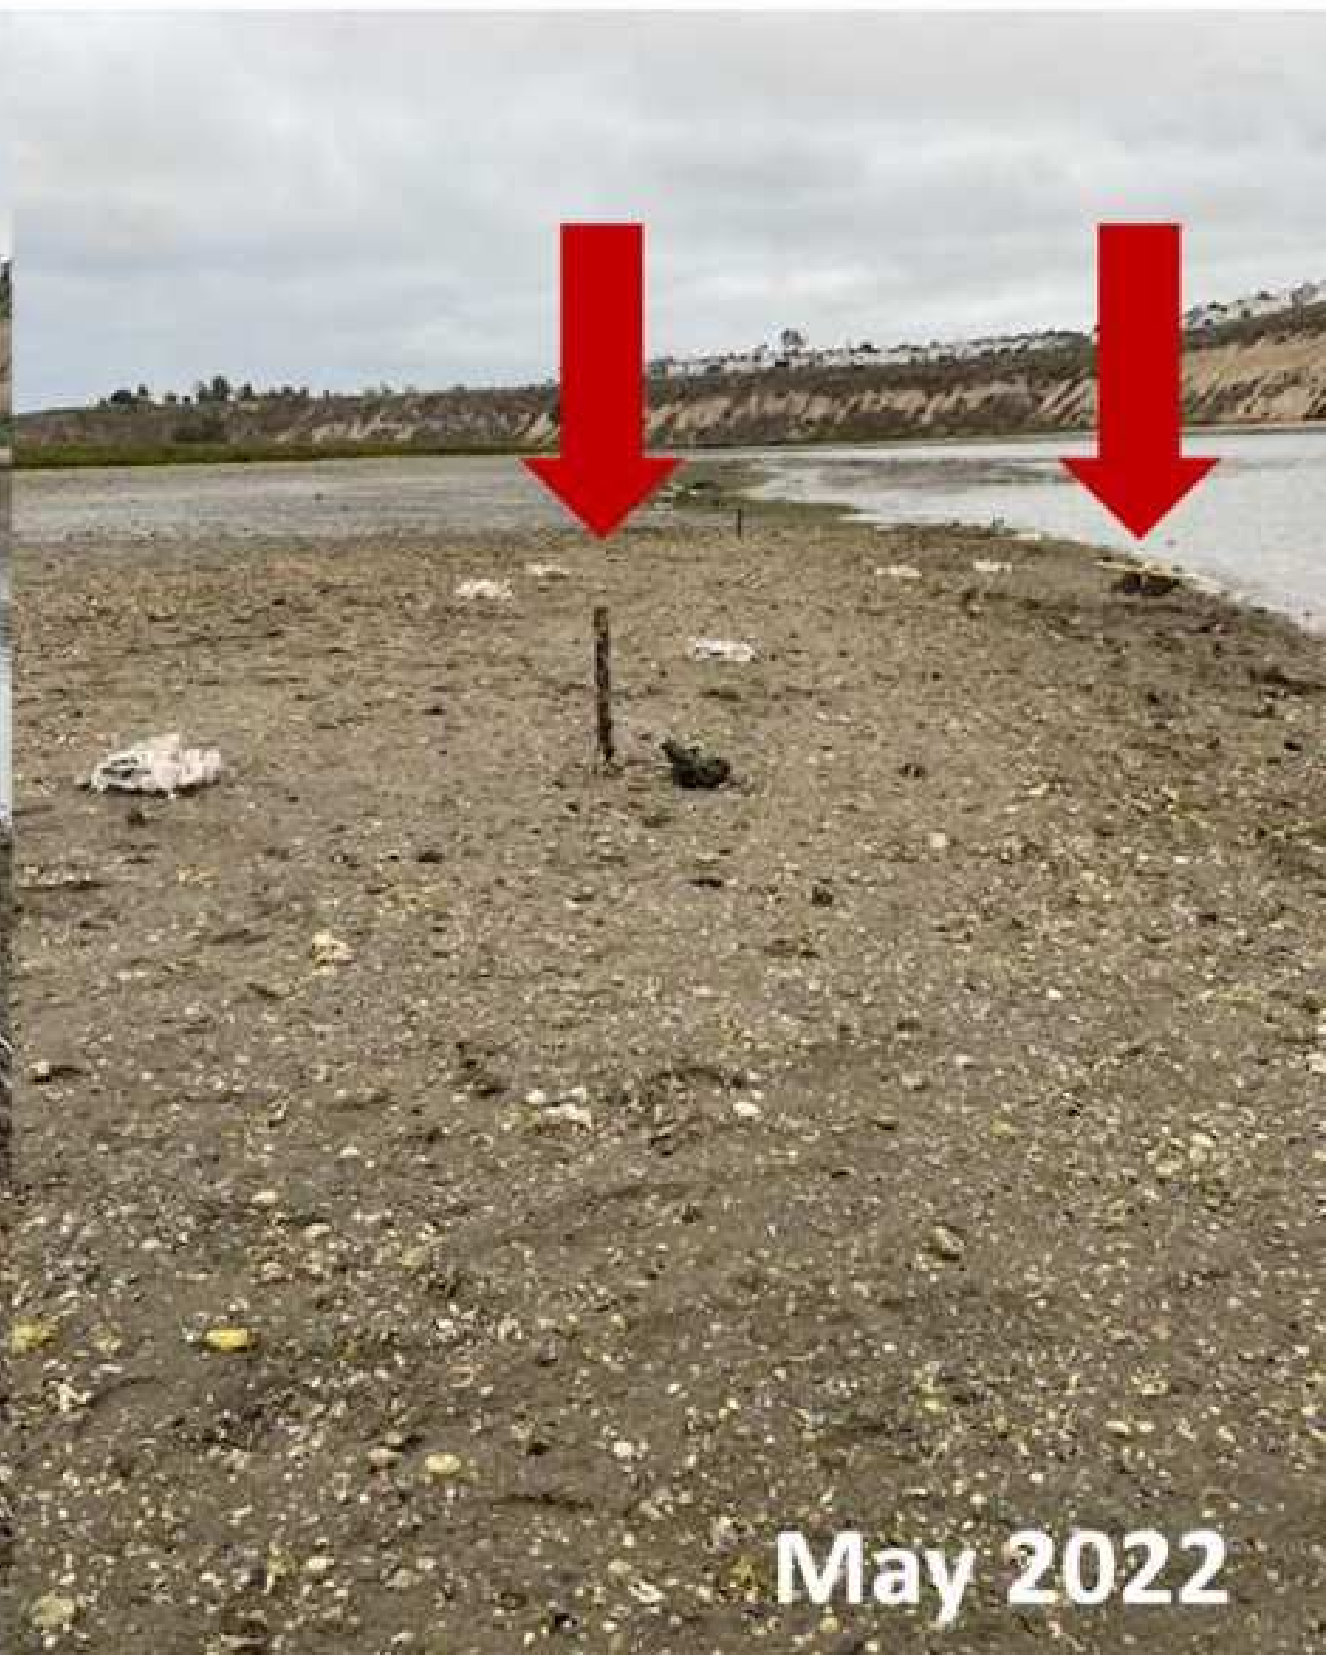
Bed integrity and shell cover declined across sites and shell migrated shoreward...

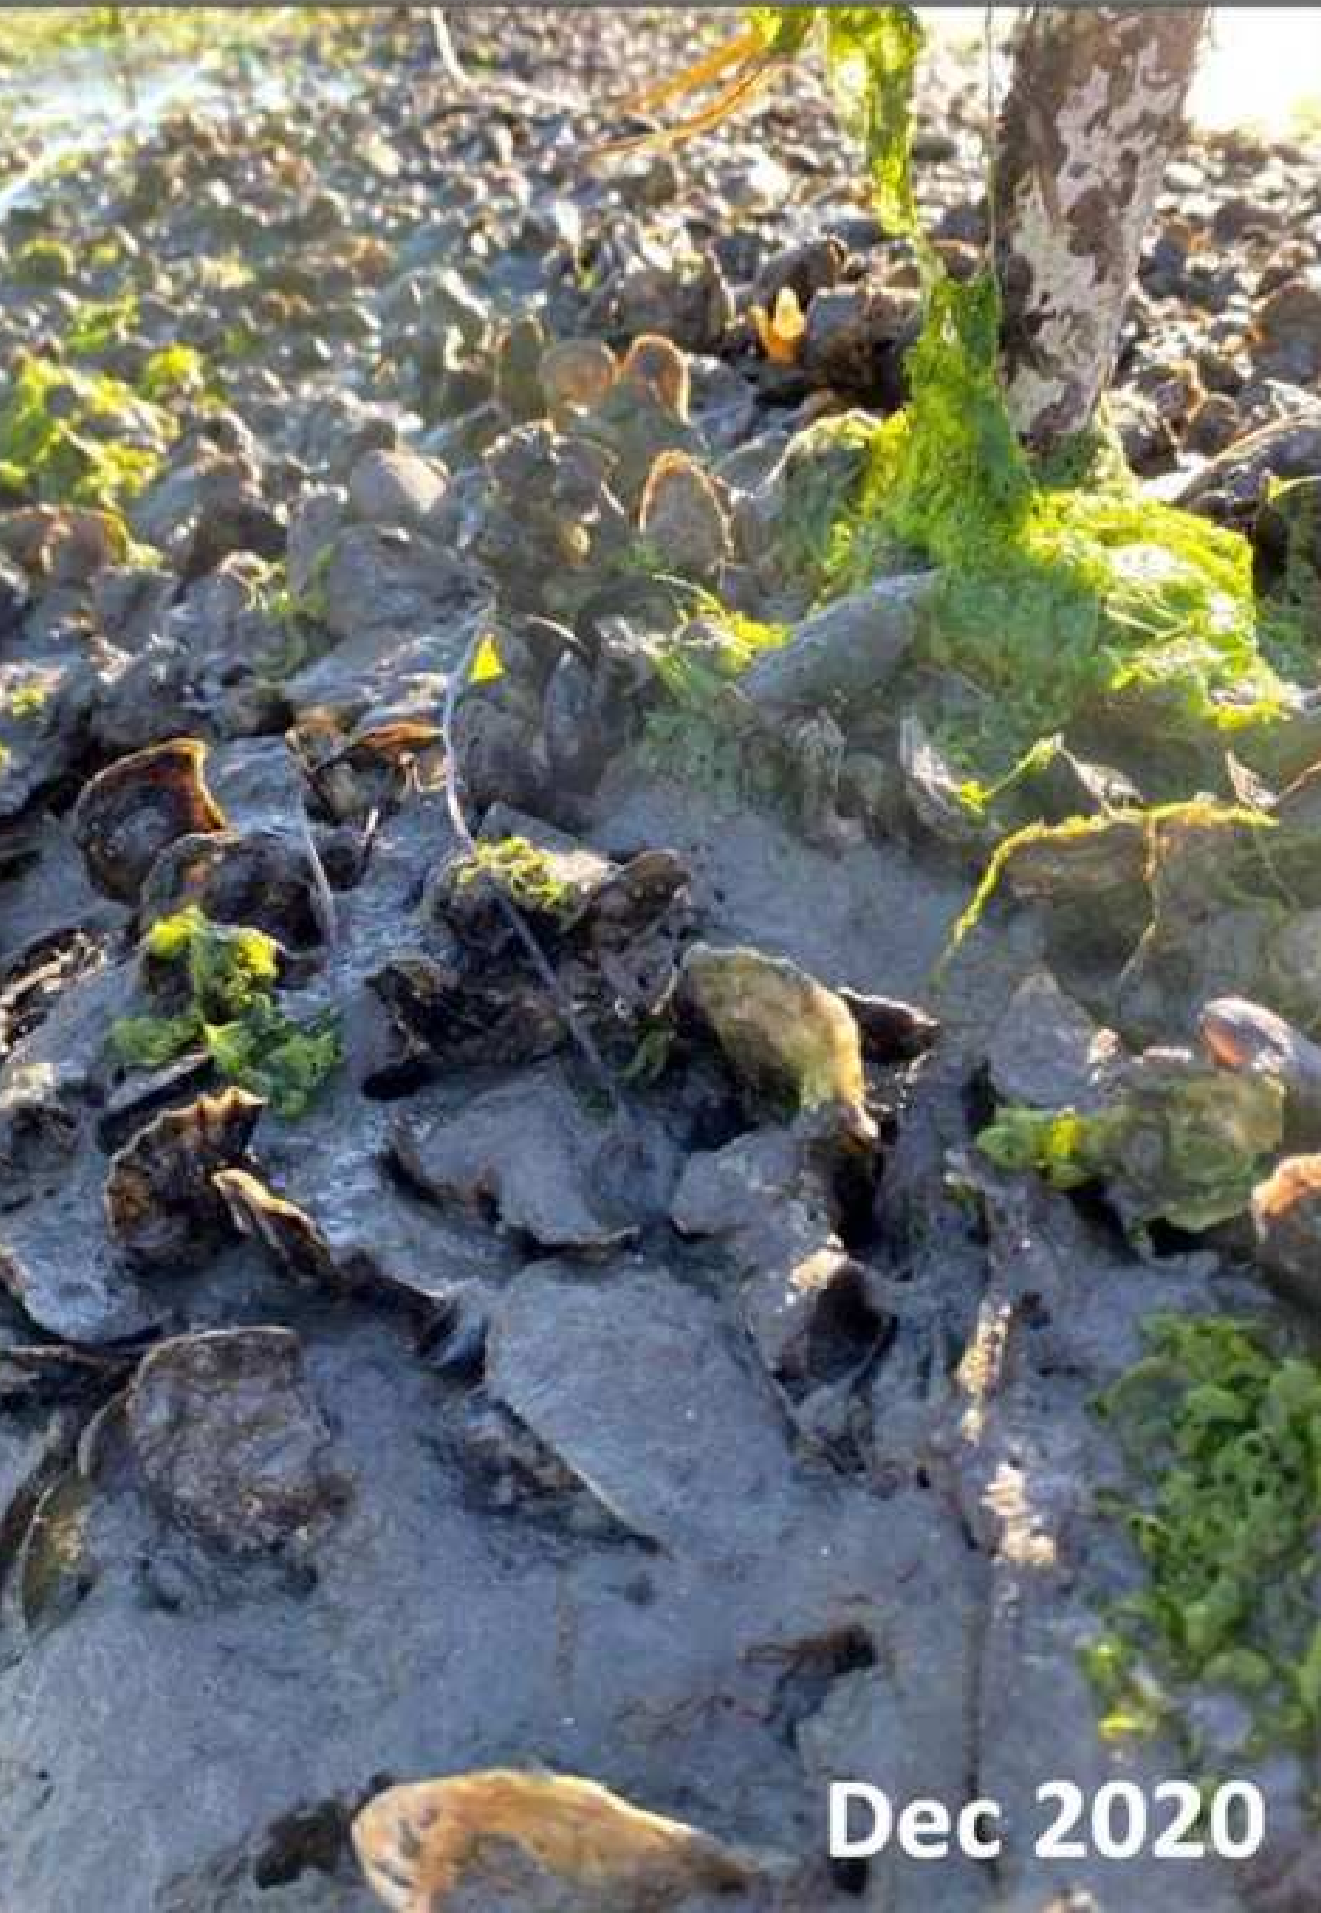
Dec 2020

...except Shellmaker
